**Flood Control Project Maintenance  
Levee Inspections**  
**LMA District Cover Sheet**  
**Spring 2017 Levee Inspection Results**

**Tehama County Flood Control and Water Conservation District**

**Spring 2017 Levee Inspection Results**

Waterway			Bank	Unit Miles
Unit No. 01 Deer Creek			Left	4.22
	Spring (March - May)	Summer (June - August)	(September - November) Fall	Winter (December - February)
Unit Maintenance Rating (Fall Only)				
Date of Inspection	4/25/2017 - 4/25/2017			
DWR Inspector	Bob Duffey			
Accompanied By	Ryan Teubert Tehama County

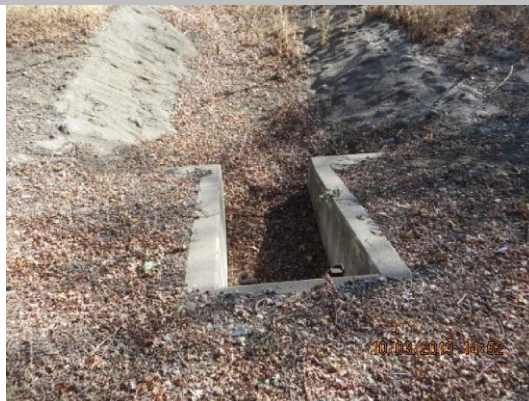
Photo 3 of 3 : UCIP\_SP\_2017\_22826\_38963.jpg

LM Start	0.38	Rating **	A/W	Issue No.	918 (cont)
LM End	0.38	Issue Type +	Ma	Location *	LS
Category	Supplemental			GPS Latitude/Longitude	
				Start	End
Item	DWR UCIP LMA Responsibility			40.051572 °	40.051572 °
				-122.182093 °	-122.182093 °
DWR ID					
Comment Code					
Inspector Comment					
FS_ID:22826					
DS_ID:20776					
EP_NO: N/A					
Repair Type: No Action Needed					
Crossing Status: Found					
UCIP Comments:					
FIELD_STRUCT_DESC: 24-inch CM drain pipe through levee, 4.5 feet below crown. Flap gate and concrete "U" headwall on waterward end. Concrete "U" headwall on landward end. Originally included in USACE O+M manual (1963). As-built drawing No. 50-4-3622.					
FS Date: 10/3/2013

Concrete U-shaped headwall with concrete swale on WS toe.

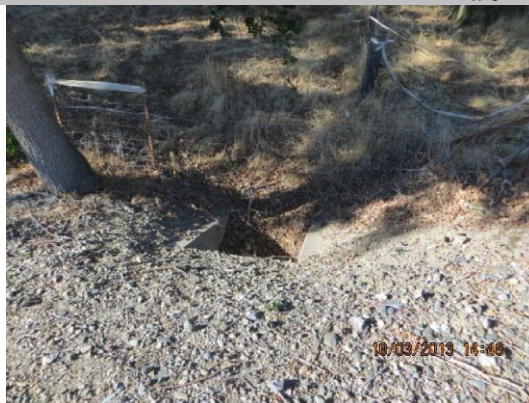
Photo 1 of 3 : UCIP\_SP\_2017\_21793\_37069.jpg

LM Start	0.51	Rating **	A/W	Issue No.	919
LM End	0.51	Issue Type +	Ma	Location *	LS
Category	Supplemental			GPS Latitude/Longitude	
				Start	End
Item	DWR UCIP LMA Responsibility			40.051211 °	40.051211 °
				-122.179663 °	-122.179663 °
DWR ID					
Comment Code					
Inspector Comment					
FS_ID:21793					
DS_ID:20777					
EP_NO: N/A					
Repair Type: No Action Needed					
Crossing Status: Found					
UCIP Comments:					
FIELD_STRUCT_DESC: 24-inch CM drain pipe through levee, 5-feet below crown. Flap gate and concrete "U" headwall on waterward end. Concrete "U" headwall on landward end. Originally included in USACE O+M manual (1963). As-built drawing No. 50-4-3622.					
FS Date: 10/3/2013

Concrete U-shaped headwall on LS toe.

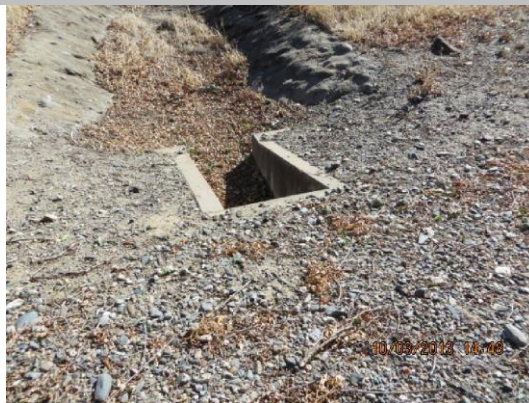
Photo 2 of 3 : UCIP\_SP\_2017\_21793\_37068.jpg

Concrete U-shaped headwall on WS toe.

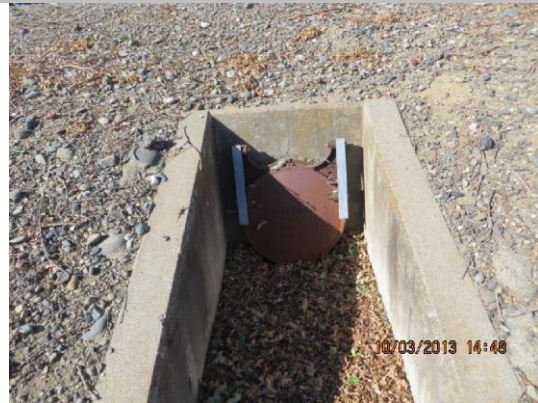
Photo 3 of 3 : UCIP\_SP\_2017\_21793\_37067.jpg

LM Start	0.51	Rating **	A/W	Issue No.	919 (cont)	
LM End	0.51	Issue Type +	Ma	Location *	LS	
Category	Supplemental			GPS Latitude/Longitude		
				Start		End
Item	DWR UCIP LMA Responsibility			40.051211 °		40.051211 °
				-122.179663 °		-122.179663 °
DWR ID						
Comment Code						
Inspector Comment						
FS_ID:21793						
DS_ID:20777						
EP_NO: N/A						
Repair Type: No Action Needed						
Crossing Status: Found						
UCIP Comments:						
FIELD_STRUCT_DESC: 24-inch CM drain pipe through levee, 5-feet below crown. Flap gate and concrete "U" headwall on waterward end. Concrete "U" headwall on landward end. Originally included in USACE O+M manual (1963). As-built drawing No. 50-4-3622.						
FS Date: 10/3/2013

Concrete U-shaped headwall and flapgate on WS toe.

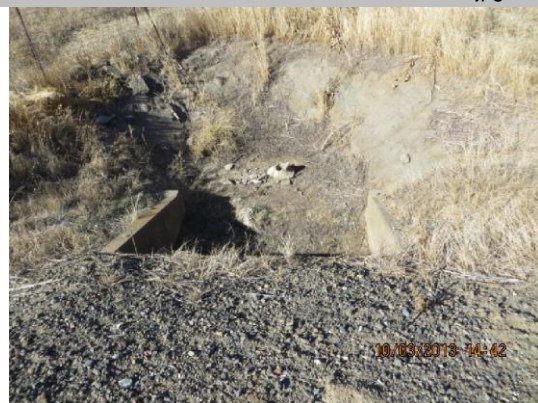
Photo 1 of 3 : UCIP\_SP\_2017\_21792\_37065.jpg

LM Start	0.64	Rating **	A/W	Issue No.	920
LM End	0.64	Issue Type +	Ma	Location *	LS
Category	Supplemental			GPS Latitude/Longitude	
				Start	End
Item	DWR UCIP LMA Responsibility			40.051699 °	40.051699 °
				-122.177320 °	-122.177320 °
DWR ID					
Comment Code					
Inspector Comment					
FS_ID:21792					
DS_ID:20778					
EP_NO: N/A					
Repair Type: No Action Needed					
Crossing Status: Found					
UCIP Comments:					
FIELD_STRUCT_DESC: 1 of 2: 36-inch CM drain pipe through levee, 8.6 feet below crown. Flap gate and concrete "U" headwall on waterward end. Concrete "U" headwall on landward end. Originally included in USACE O+M manual (1963). As-built drawing No. 50-4-3622.					
FS Date: 10/3/2013

Concrete U-shaped headwall on LS toe.

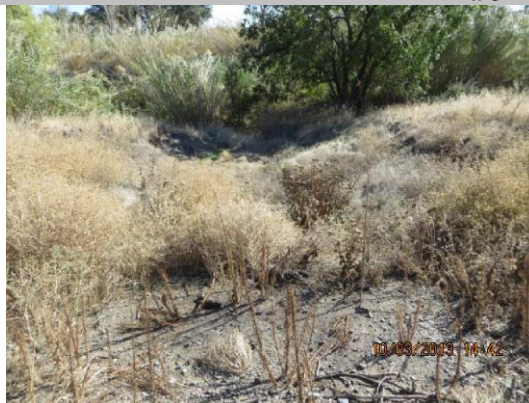
Photo 2 of 3 : UCIP\_SP\_2017\_21792\_37064.jpg

Concrete U-shaped headwall on WS toe.

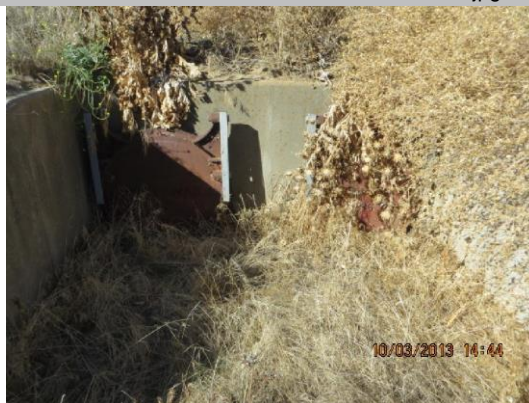
Photo 3 of 3 : UCIP\_SP\_2017\_21792\_37063.jpg

Concrete U-shaped headwall and flapgate on WS toe.

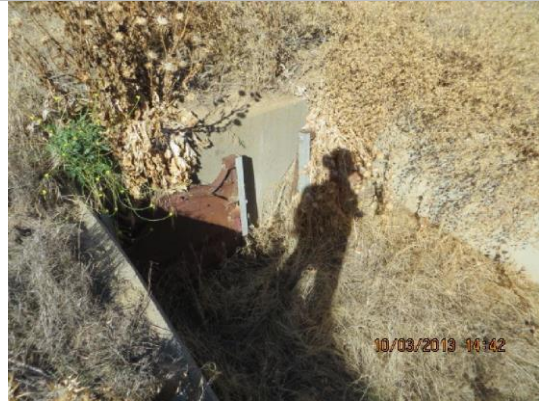
Photo 3 of 3 : UCIP\_SP\_2017\_51443\_37059.jpg

Comment Code					
Inspector Comment					
FS_ID:51443 DS_ID:20880 EP_NO: N/A Repair Type: Non-Urgent Crossing Status: Found UCIP Comments: 12/05/2016 Crossing has been downgraded from Urgent to Non-Urgent vegetation found on WS but does not appear to prevent proper function of flap gate. Recommend clearing dry vegetation on WS above concrete headwall.(O. Magana - DWR UCIP)10/03/2013 Flapgate operation hindered by soil and vegetation on WS toe. (W. Wylie - DWR UCIP) FIELD_STRUCT_DESC: 2 of 2: 36-inch corrugated metal drainage pipe through levee, 8.6 feet below crown. Flap gate and concrete "U" headwall located on the waterside (WS) end. Concrete "U" headwall located on the landside (LS) end. [Additional Reference(s): DWR Levee Log, 1992. USACE Sacramento O&M Manual, Unit 510, April 1963, As-built drawing No. 50-4-3622 (HLM 0.65)] FS Date: 12/5/2016

Concrete U-shaped headwall and flapgate on WS toe.

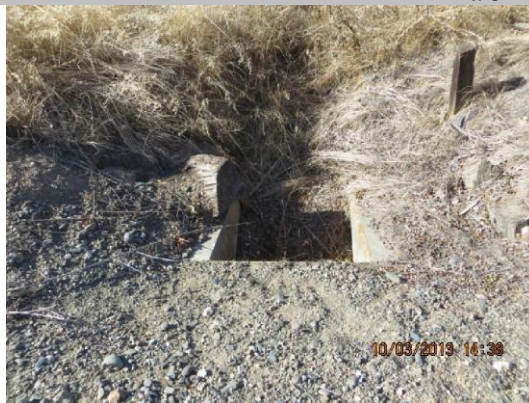
Photo 1 of 3 : UCIP\_SP\_2017\_21790\_37057.jpg

LM Start	0.75	Rating **	A/W	Issue No.	922
LM End	0.75	Issue Type +	Ma	Location *	LS
Category	Supplemental			GPS Latitude/Longitude	
				Start	End
Item	DWR UCIP LMA Responsibility			40.052194 °	40.052194 °
				-122.175390 °	-122.175390 °
DWR ID					
Comment Code					
Inspector Comment					
FS_ID:21790					
DS_ID:20779					
EP_NO: N/A					
Repair Type: No Action Needed					
Crossing Status: Found					
UCIP Comments:					
FIELD_STRUCT_DESC: 24-inch CM drain pipe through levee, 5.8 feet below crown. Flap gate and concrete "U" headwall on waterward end. Concrete "U" headwall on landward end. Originally included in USACE O+M manual (1963). As-built drawing No. 50-4-3622.					
FS Date: 10/3/2013

Concrete U-shaped headwall on LS toe.

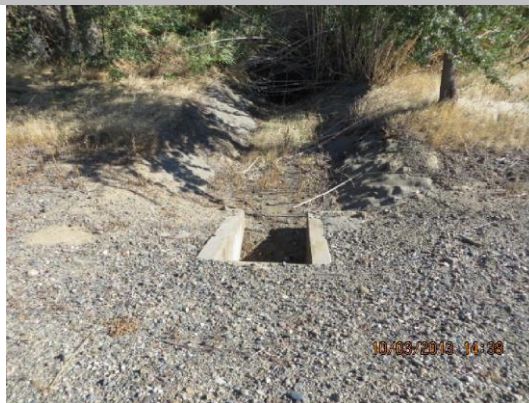
Photo 2 of 3 : UCIP\_SP\_2017\_21790\_37056.jpg

Concrete U-shaped headwall on WS toe.

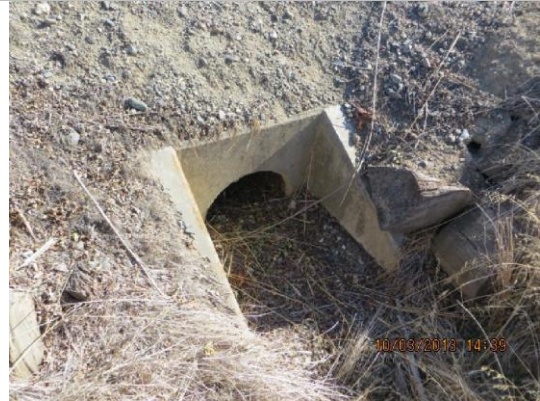
Photo 3 of 3 : UCIP\_SP\_2017\_21790\_37055.jpg

Concrete U-shaped headwall on LS toe.

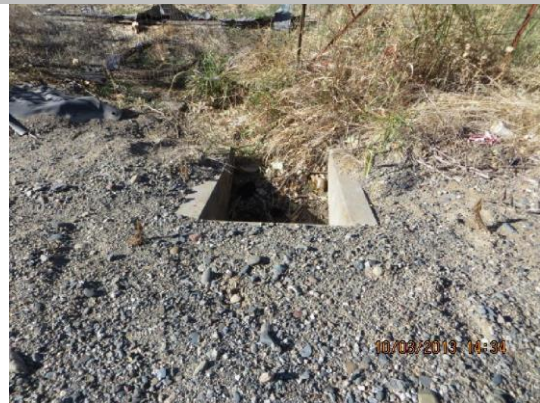
Photo 1 of 3 : UCIP\_SP\_2017\_22827\_38970.jpg

LM Start	0.91	Rating **	A/W	Issue No.	923
LM End	0.91	Issue Type +	Ma	Location *	LS
Category	Supplemental			GPS Latitude/Longitude	
				Start	End
Item	DWR UCIP LMA Responsibility			40.053401 °	40.053401 °
				-122.172848 °	-122.172848 °
DWR ID					
Comment Code					
Inspector Comment					
FS_ID:22827					
DS_ID:20780					
EP_NO: N/A					
Repair Type: No Action Needed					
Crossing Status: Found					
UCIP Comments:					
FIELD_STRUCT_DESC: 24-inch CM drain pipe through levee, 4.5-feet below crown. Flap gate and concrete "U" headwall on waterward end. Concrete "U" headwall on landward end. Originally included in USACE O+M manual (1963). As-built drawing No. 50-4-3622.					
FS Date: 10/3/2013

Concrete U-shaped headwall on LS toe.

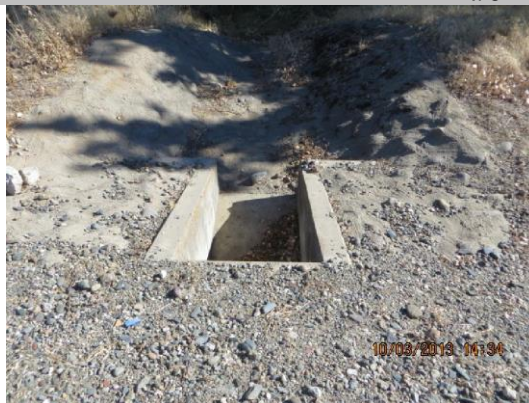
Photo 2 of 3 : UCIP\_SP\_2017\_22827\_38969.jpg

Concrete U-shaped headwall on WS toe.

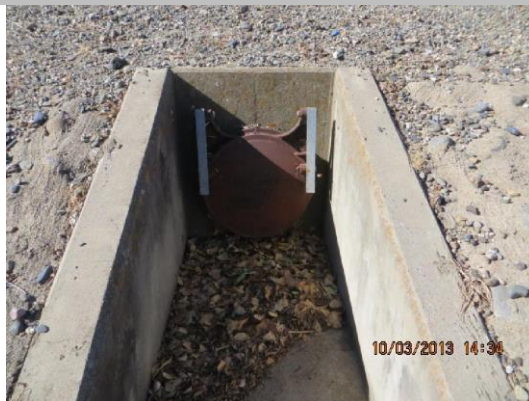
Photo 3 of 3 : UCIP\_SP\_2017\_22827\_38972.jpg

Flapgate on headwall at WS toe.

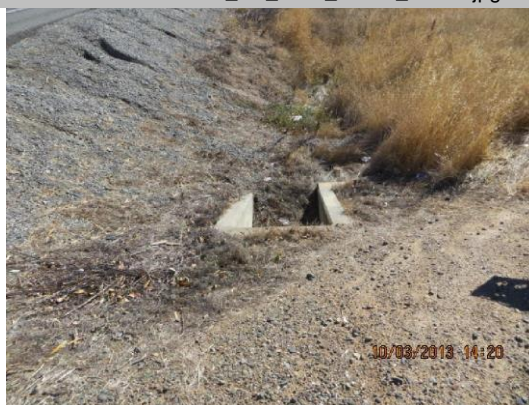
Photo 1 of 3 : UCIP\_SP\_2017\_21788\_37050.jpg

LM Start	1.07	Rating **	A/W	Issue No.	924
LM End	1.07	Issue Type +	Ma	Location *	WS
Category	Supplemental			GPS Latitude/Longitude	
				Start	End
Item	DWR UCIP LMA Responsibility			40.052400 °	40.052400 °
				-122.170279 °	-122.170279 °
DWR ID					
Comment Code					
Inspector Comment					
FS_ID:21788					
DS_ID:20790					
EP_NO: N/A					
Repair Type: No Action Needed					
Crossing Status: Found					
UCIP Comments:					
FIELD_STRUCT_DESC: 24-inch CM pipe through levee, 5-feet below crown. Flap gate and concrete "U" headwall on waterward end.					
Concrete "U" headwall on landward end. Originally included in USACE O+M manual (1963). As-built drawing No. 50-4-3622.					
FS Date: 10/3/2013

Concrete U-shaped headwall on WS toe.

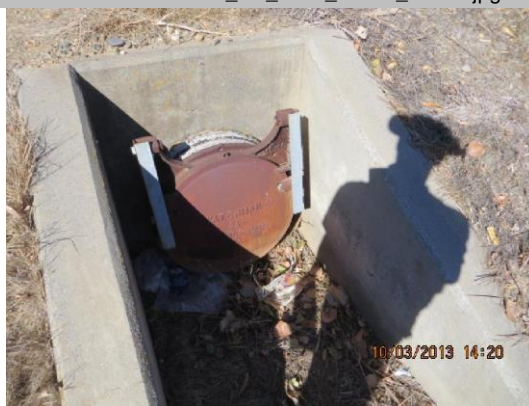
Photo 2 of 3 : UCIP\_SP\_2017\_21788\_37053.jpg

Concrete U-shaped headwall and flapgate on WS toe.

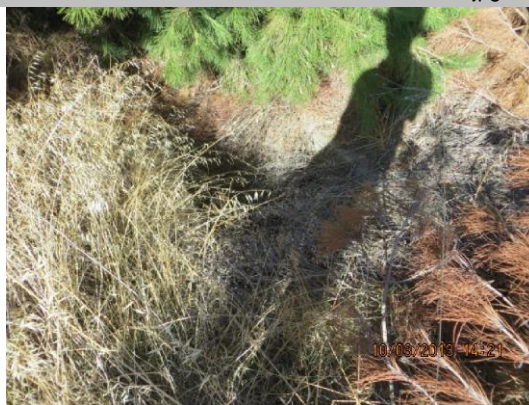
Photo 3 of 3 : UCIP\_SP\_2017\_21788\_37052.jpg

Concrete U-shaped headwall on LS toe.

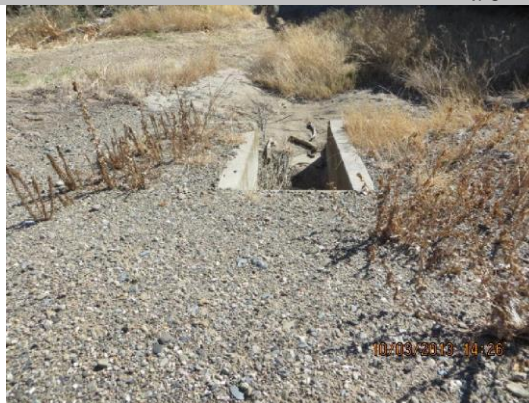
Photo 1 of 2 : UCIP\_SP\_2017\_21786\_37048.jpg

LM Start	1.11	Rating **	A/W	Issue No.	925
LM End	1.11	Issue Type +	Ma	Location *	WS
Category	Supplemental			GPS Latitude/Longitude	
				Start	End
Item	DWR UCIP LMA Responsibility			40.051958 °	40.051958 °
				-122.170031 °	-122.170031 °
DWR ID					
Comment Code					
Inspector Comment					
FS_ID:21786					
DS_ID:20773					
EP_NO: N/A					
Repair Type: No Action Needed					
Crossing Status: Found					
UCIP Comments:					
FIELD_STRUCT_DESC: 24-inch CM drain pipe through levee, 5.1 feet below crown. Flap gate and concrete "U" headwall on waterward and. Concrete "U" headwall on landward end. Originally included in USACE O+M manual (1963). As-built drawing No. 50-4-3622.					
FS Date: 10/3/2013

Concrete U-shaped headwall and flapgate on WS slope.

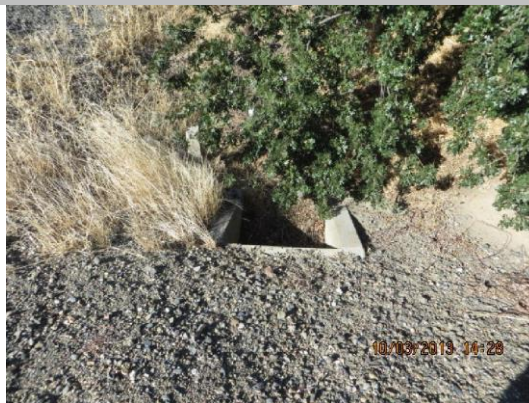
Photo 2 of 2 : UCIP\_SP\_2017\_21786\_37047.jpg

Concrete U-shaped headwall on LS toe.

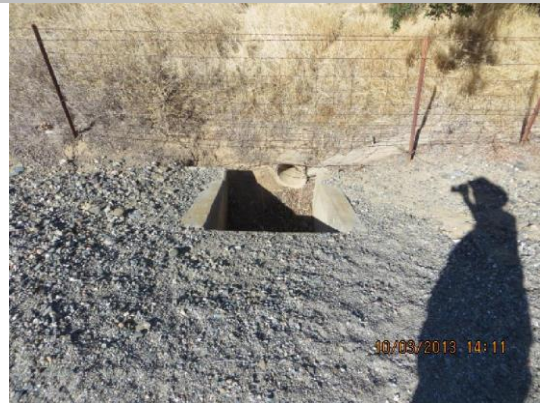
Photo 1 of 3 : UCIP\_SP\_2017\_21778\_37037.jpg

LM Start	1.30	Rating **	A/W	Issue No.	926
LM End	1.30	Issue Type +	Ma	Location *	CR
Category	Supplemental			GPS Latitude/Longitude	
				Start	End
Item	DWR UCIP LMA Responsibility			40.051563 °	40.051563 °
				-122.166630 °	-122.166630 °
DWR ID					
Comment Code					
Inspector Comment					
FS_ID:21778					
DS_ID:20782					
EP_NO: N/A					
Repair Type: No Action Needed					
Crossing Status: Found					
UCIP Comments:					
FIELD_STRUCT_DESC: 24-inch CM pipe through levee, 4.5-feet below crown. Flap gate and concrete "U" headwall on waterward end. Concrete "U" headwall on landward end. Originally included in USACE O+M manual (1963). As-built drawing No. 50-4-3622.					
FS Date: 10/3/2013

Concrete U-shaped headwall on LS toe.

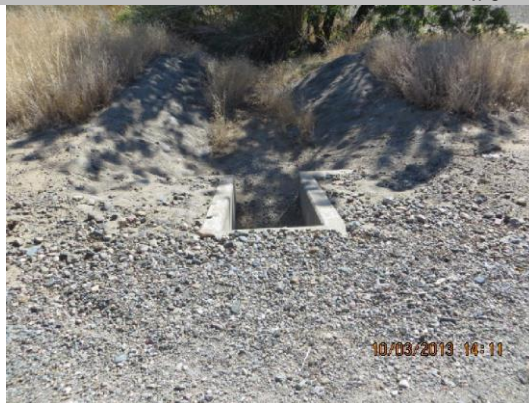
Photo 2 of 3 : UCIP\_SP\_2017\_21778\_37036.jpg

FS\_ID:21778  
DS\_ID:20782  
EP\_NO: N/A  
Repair Type: No Action Needed  
Crossing Status: Found  
UCIP Comments:  
FIELD\_STRUCT\_DESC: 24-inch CM pipe through levee, 4.5-feet below crown. Flap gate and concrete "U" headwall on waterward end. Concrete "U" headwall on landward end. Originally included in USACE O+M manual (1963). As-built drawing No. 50-4-3622.  
FS Date: 10/3/2013

Concrete U-shaped headwall on WS toe.

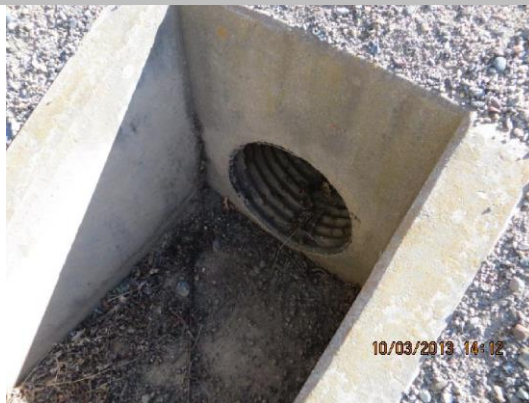
Photo 3 of 3 : UCIP\_SP\_2017\_21778\_37035.jpg

Concrete U-shaped headwall on LS toe.

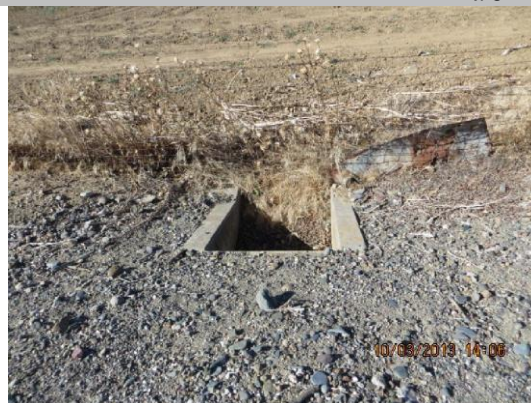
Photo 1 of 3 : UCIP\_SP\_2017\_21776\_37029.jpg

LM Start	1.56	Rating **	A/W	Issue No.	927
LM End	1.56	Issue Type +	Ma	Location *	WS
Category	Supplemental			GPS Latitude/Longitude	
				Start	End
Item	DWR UCIP LMA Responsibility			40.052495 °	40.052495 °
				-122.161921 °	-122.161921 °
DWR ID					
Comment Code					
Inspector Comment					
FS_ID:21776					
DS_ID:20783					
EP_NO: N/A					
Repair Type: No Action Needed					
Crossing Status: Found					
UCIP Comments:					
FIELD_STRUCT_DESC: 24-inch CM pipe through levee, 5.8 feet below crown. Flap gate and concrete "U" headwall on waterward end.					
Concrete "U" headwall on landward end. Originally included in USACE O+M manual (1963). As-built drawing No. 50-4-3622.					
FS Date: 10/3/2013

Concrete U-shaped headwall on LS toe.

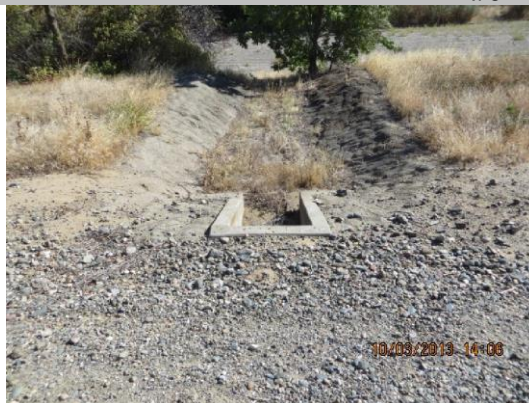
Photo 2 of 3 : UCIP\_SP\_2017\_21776\_37028.jpg

LM Start	1.56	Rating **	A/W	Issue No.	927 (cont)
LM End	1.56	Issue Type +	Ma	Location *	WS
Category	Supplemental			GPS Latitude/Longitude	
				Start	End
Item	DWR UCIP LMA Responsibility			40.052495 °	40.052495 °
				-122.161921 °	-122.161921 °
DWR ID					
Comment Code					
Inspector Comment					
FS_ID:21776					
DS_ID:20783					
EP_NO: N/A					
Repair Type: No Action Needed					
Crossing Status: Found					
UCIP Comments:					
FIELD_STRUCT_DESC: 24-inch CM pipe through levee, 5.8 feet below crown. Flap gate and concrete "U" headwall on waterward end.					
Concrete "U" headwall on landward end. Originally included in USACE O+M manual (1963). As-built drawing No. 50-4-3622.					
FS Date: 10/3/2013

Concrete U-shaped headwall on WS toe.

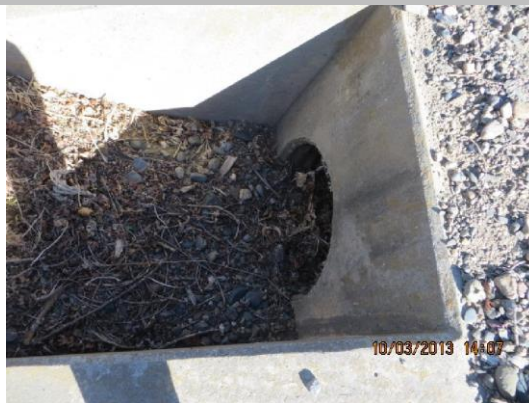
Photo 3 of 3 : UCIP\_SP\_2017\_21776\_37027.jpg

Concrete U-shaped headwall on LS toe.

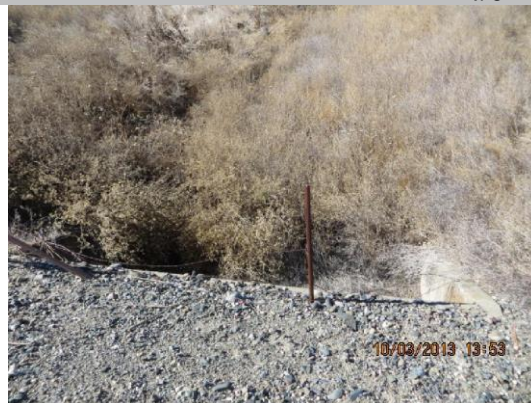
Photo 1 of 3 : UCIP\_SP\_2017\_21769\_37004.jpg

LM Start	1.69	Rating **	A/W	Issue No.	928
LM End	1.69	Issue Type +	Ma	Location *	WS
Category	Supplemental			GPS Latitude/Longitude	
				Start	End
Item	DWR UCIP LMA Responsibility			40.053590 °	40.053590 °
				-122.159982 °	-122.159982 °
DWR ID					
Comment Code					
Inspector Comment					
FS_ID:21769					
DS_ID:20786					
EP_NO: N/A					
Repair Type: No Action Needed					
Crossing Status: Found					
UCIP Comments:					
FIELD_STRUCT_DESC: 1 of 3: 36-inch CM pipe through levee, 7.3 feet below crown. Flap gate and concrete "U" headwall on waterward end. Concrete "U" headwall on landward end. Originally included in USACE O+M manual (1963). As-built drawing No. 50-4-3622.					
FS Date: 10/3/2013

Concrete inlet on LS toe.

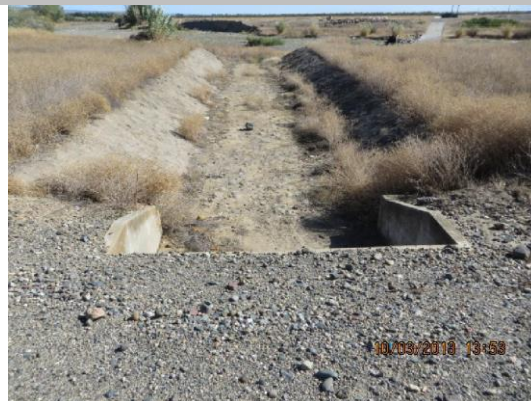
Photo 2 of 3 : UCIP\_SP\_2017\_21769\_37003.jpg

Concrete inlet on WS toe.

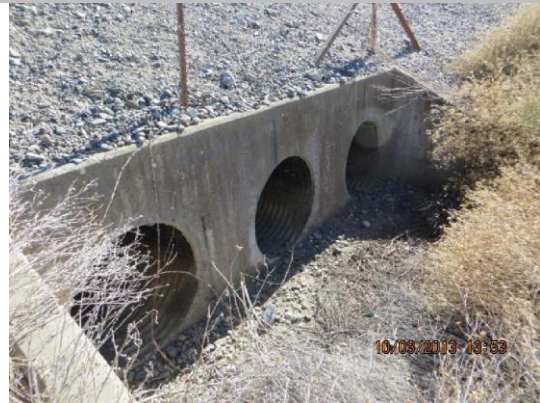
Photo 3 of 3 : UCIP\_SP\_2017\_21769\_37002.jpg

LM Start	1.69	Rating **	A/W	Issue No.	928 (cont)
LM End	1.69	Issue Type +	Ma	Location *	WS
Category	Supplemental			GPS Latitude/Longitude	
				Start	End
Item	DWR UCIP LMA Responsibility			40.053590 °	40.053590 °
				-122.159982 °	-122.159982 °
DWR ID					
Comment Code					
Inspector Comment					
FS_ID:21769 DS_ID:20786 EP_NO: N/A Repair Type: No Action Needed Crossing Status: Found UCIP Comments: FIELD_STRUCT_DESC: 1 of 3: 36-inch CM pipe through levee, 7.3 feet below crown. Flap gate and concrete "U" headwall on waterward end. Concrete "U" headwall on landward end. Originally included in USACE O+M manual (1963). As-built drawing No. 50-4-3622. FS Date: 10/3/2013

Concrete inlet on LS toe.

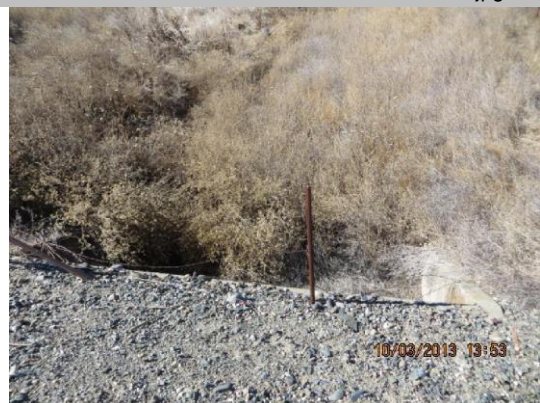
Photo 1 of 3 : UCIP\_SP\_2017\_21768\_37000.jpg

LM Start	1.69	Rating **	A/W	Issue No.	929
LM End	1.69	Issue Type +	Ma	Location *	WS
Category	Supplemental			GPS Latitude/Longitude	
				Start	End
Item	DWR UCIP LMA Responsibility			40.053601 °	40.053601 °
				-122.159966 °	-122.159966 °
DWR ID					
Comment Code					
Inspector Comment					
FS_ID:21768					
DS_ID:20883					
EP_NO: N/A					
Repair Type: No Action Needed					
Crossing Status: Found					
UCIP Comments:					
FIELD_STRUCT_DESC: 2 of 3: 36-inch CM pipe through levee, 7.3 feet below crown. Flap gate and concrete "U" headwall on waterward end. Concrete "U" headwall on landward end. Originally included in USACE O+M manual (1963). As-built drawing No. 50-4-3622.					
FS Date: 10/3/2013

Concrete headwall on LS toe.

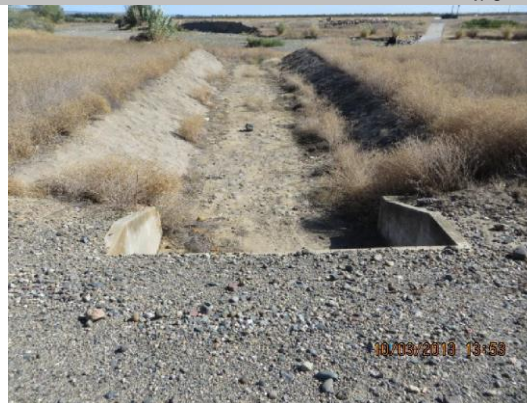
Photo 2 of 3 : UCIP\_SP\_2017\_21768\_36999.jpg

LM Start	1.69	Rating **	A/W	Issue No.	929 (cont)
LM End	1.69	Issue Type +	Ma	Location *	WS
Category	Supplemental			GPS Latitude/Longitude	
				Start	End
Item	DWR UCIP LMA Responsibility			40.053601 °	40.053601 °
				-122.159966 °	-122.159966 °
DWR ID					
Comment Code					
Inspector Comment					
FS_ID:21768					
DS_ID:20883					
EP_NO: N/A					
Repair Type: No Action Needed					
Crossing Status: Found					
UCIP Comments:					
FIELD_STRUCT_DESC: 2 of 3: 36-inch CM pipe through levee, 7.3 feet below crown. Flap gate and concrete "U" headwall on waterward end. Concrete "U" headwall on landward end. Originally included in USACE O+M manual (1963). As-built drawing No. 50-4-3622.					
FS Date: 10/3/2013

Concrete headwall on WS toe.

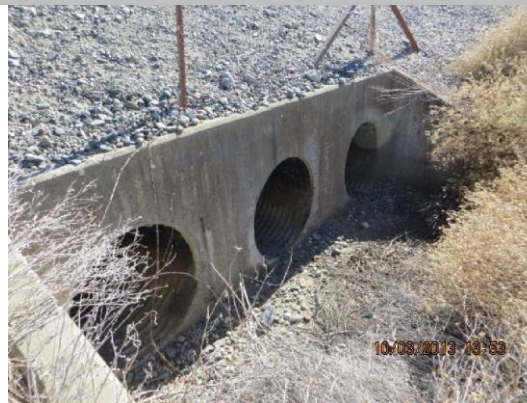
Photo 3 of 3 : UCIP\_SP\_2017\_21768\_36998.jpg

Concrete headwall on LS toe.

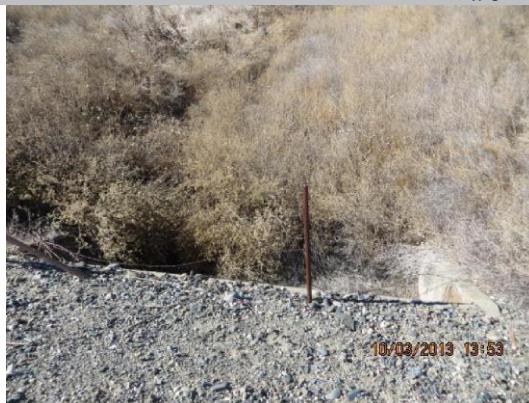
Photo 1 of 3 : UCIP\_SP\_2017\_21767\_36996.jpg

LM Start	1.69	Rating **	A/W	Issue No.	930
LM End	1.69	Issue Type +	Ma	Location *	WS
Category	Supplemental			GPS Latitude/Longitude	
				Start	End
Item	DWR UCIP LMA Responsibility			40.053614 °	40.053614 °
				-122.159956 °	-122.159956 °
DWR ID					
Comment Code					
Inspector Comment					
FS_ID:21767					
DS_ID:20884					
EP_NO: N/A					
Repair Type: No Action Needed					
Crossing Status: Found					
UCIP Comments:					
FIELD_STRUCT_DESC: 3 of 3: 36-inch CM pipe through levee, 7.3 feet below crown. Flap gate and concrete "U" headwall on waterward end. Concrete "U" headwall on landward end. Originally included in USACE O+M manual (1963). As-built drawing No. 50-4-3622.					
FS Date: 10/3/2013

Concrete headwall on LS slope.

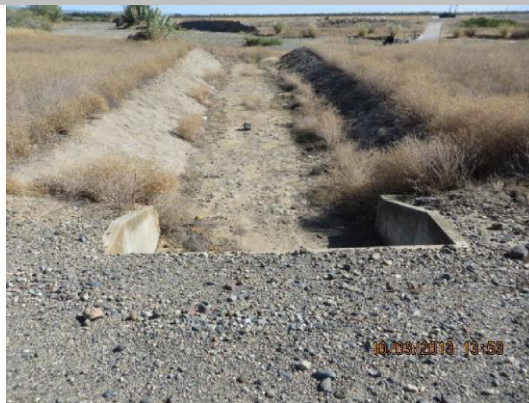
Photo 2 of 3 : UCIP\_SP\_2017\_21767\_36995.jpg

Concrete headwall on WS toe.

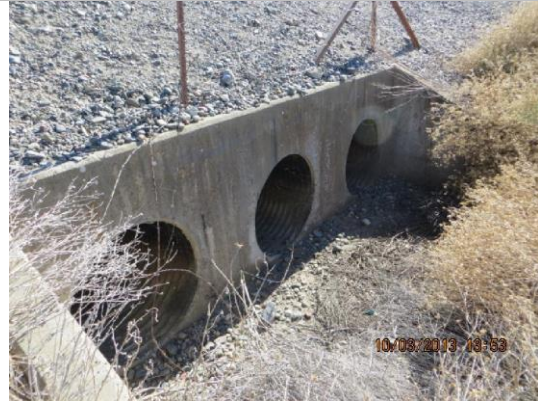
Photo 3 of 3 : UCIP\_SP\_2017\_21767\_36994.jpg

LM Start	1.69	Rating **	A/W	Issue No.	930 (cont)
LM End	1.69	Issue Type +	Ma	Location *	WS
Category	Supplemental			GPS Latitude/Longitude	
				Start	End
Item	DWR UCIP LMA Responsibility			40.053614 °	40.053614 °
				-122.159956 °	-122.159956 °
DWR ID					
Comment Code					
Inspector Comment					
FS_ID:21767 DS_ID:20884 EP_NO: N/A Repair Type: No Action Needed Crossing Status: Found UCIP Comments: FIELD_STRUCT_DESC: 3 of 3: 36-inch CM pipe through levee, 7.3 feet below crown. Flap gate and concrete "U" headwall on waterward end. Concrete "U" headwall on landward end. Originally included in USACE O+M manual (1963). As-built drawing No. 50-4-3622. FS Date: 10/3/2013

Concrete headwall on LS toe.

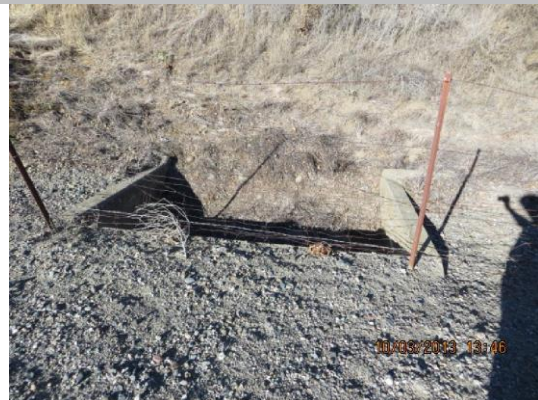
Photo 1 of 3 : UCIP\_SP\_2017\_21766\_36992.jpg

LM Start	1.99	Rating **	A/W	Issue No.	931
LM End	1.99	Issue Type +	Ma	Location *	WS
Category	Supplemental			GPS Latitude/Longitude	
				Start	End
Item	DWR UCIP LMA Responsibility			40.052731 °	40.052731 °
				-122.154695 °	-122.154695 °
DWR ID					
Comment Code					
Inspector Comment					
FS_ID:21766					
DS_ID:20787					
EP_NO: N/A					
Repair Type: No Action Needed					
Crossing Status: Found					
UCIP Comments:					
FIELD_STRUCT_DESC: 1 of 2: 36-inch CM pipe through the levee, 7.6 feet below crown. Flap gate and concrete "U" headwall on waterward end. Concrete "U" headwall on landward end. Originally included in USACE O+M manual (1963). As-built drawing No. 50-4-3622.					
FS Date: 10/3/2013

Concrete headwall on LS toe.

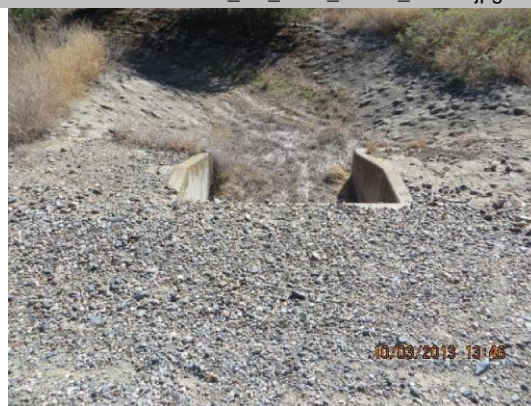
Photo 2 of 3 : UCIP\_SP\_2017\_21766\_36991.jpg

LM Start	1.99	Rating **	A/W	Issue No.	931 (cont)
LM End	1.99	Issue Type +	Ma	Location *	WS
Category	Supplemental			GPS Latitude/Longitude	
				Start	End
Item	DWR UCIP LMA Responsibility			40.052731 °	40.052731 °
				-122.154695 °	-122.154695 °
DWR ID					
Comment Code					
Inspector Comment					
FS_ID:21766					
DS_ID:20787					
EP_NO: N/A					
Repair Type: No Action Needed					
Crossing Status: Found					
UCIP Comments:					
FIELD_STRUCT_DESC: 1 of 2: 36-inch CM pipe through the levee, 7.6 feet below crown. Flap gate and concrete "U" headwall on waterward end. Concrete "U" headwall on landward end. Originally included in USACE O+M manual (1963). As-built drawing No. 50-4-3622.					
FS Date: 10/3/2013

Concrete headwall on WS toe.

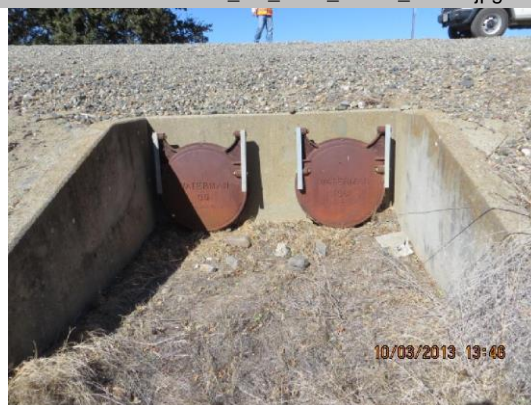
Photo 3 of 3 : UCIP\_SP\_2017\_21766\_36990.jpg

Flapgate on WS toe.

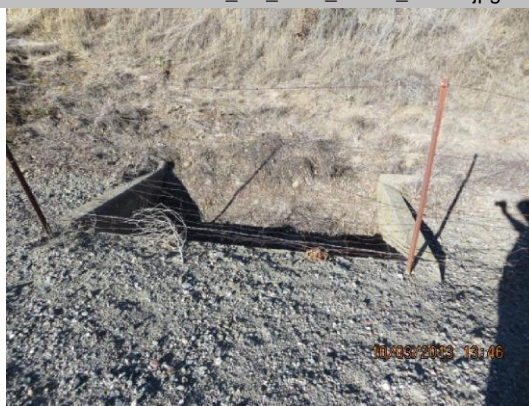
Photo 1 of 3 : UCIP\_SP\_2017\_22828\_38978.jpg

LM Start	1.99	Rating **	A/W	Issue No.	932
LM End	1.99	Issue Type +	Ma	Location *	WS
Category	Supplemental			GPS Latitude/Longitude	
				Start	End
Item	DWR UCIP LMA Responsibility			40.052729 °	40.052729 °
				-122.154673 °	-122.154673 °
DWR ID					
Comment Code					
Inspector Comment					
FS_ID:22828 DS_ID:20885 EP_NO: N/A Repair Type: No Action Needed Crossing Status: Found UCIP Comments: FIELD_STRUCT_DESC: 2 of 2: 36-inch CM pipe through the levee, 7.6 feet below crown. Flap gate and concrete "U" headwall on waterward end. Concrete "U" headwall on landward end. Originally included in USACE O+M manual (1963). As-built drawing No. 50-4-3622. FS Date: 10/3/2013

Concrete headwall on LS toe.

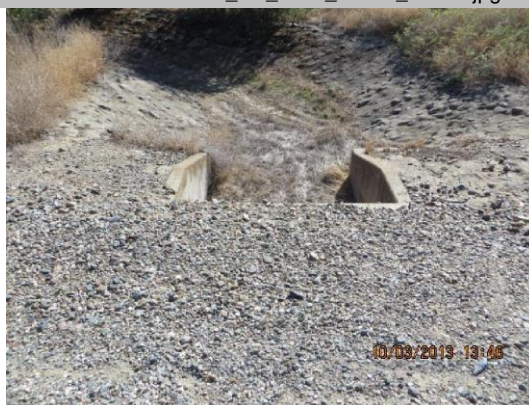
Photo 2 of 3 : UCIP\_SP\_2017\_22828\_38977.jpg

Concrete headwall and concrete channel on WS toe.

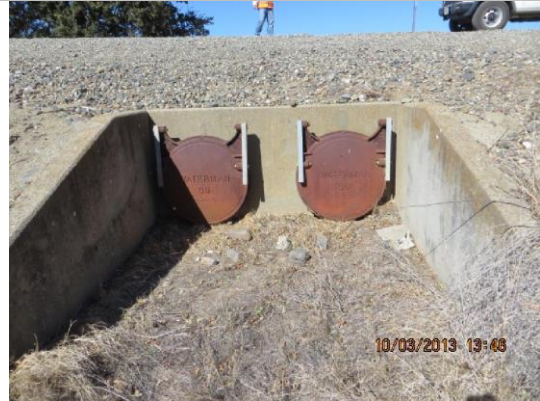
Photo 3 of 3 : UCIP\_SP\_2017\_22828\_38980.jpg

LM Start	1.99	Rating **	A/W	Issue No.	932 (cont)	
LM End	1.99	Issue Type +	Ma	Location *	WS	
Category	Supplemental			GPS Latitude/Longitude		
				Start	End	
Item	DWR UCIP LMA Responsibility			40.052729 °	40.052729 °	
				-122.154673 °	-122.154673 °	
DWR ID						
Comment Code						
Inspector Comment						
FS_ID:22828						
DS_ID:20885						
EP_NO: N/A						
Repair Type: No Action Needed						
Crossing Status: Found						
UCIP Comments:						
FIELD_STRUCT_DESC: 2 of 2: 36-inch CM pipe through the levee, 7.6 feet below crown. Flap gate and concrete "U" headwall on waterward end. Concrete "U" headwall on landward end. Originally included in USACE O+M manual (1963). As-built drawing No. 50-4-3622.						
FS Date: 10/3/2013

Flapgate on headwall at WS toe.

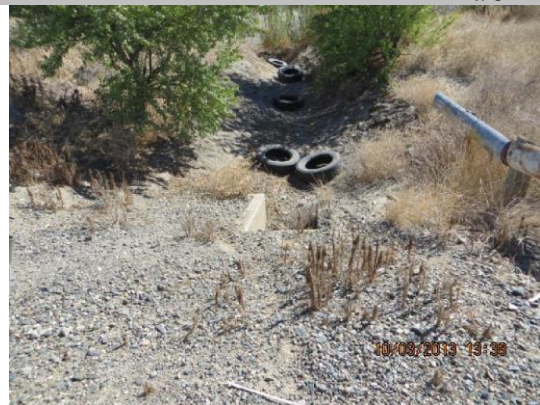
Photo 1 of 3 : UCIP\_SP\_2017\_21763\_36982.jpg

LM Start	2.21	Rating **	A/W	Issue No.	933
LM End	2.21	Issue Type +	Ma	Location *	WS
Category	Supplemental			GPS Latitude/Longitude	
				Start	End
Item	DWR UCIP LMA Responsibility			40.051985 °	40.051985 °
				-122.150737 °	-122.150737 °
DWR ID					
Comment Code					
Inspector Comment					
FS_ID:21763					
DS_ID:20788					
EP_NO: N/A					
Repair Type: No Action Needed					
Crossing Status: Found					
UCIP Comments:					
FIELD_STRUCT_DESC: 24-inch CM pipe through levee, 5.9 feet below crown. Flap gate and concrete "U" headwall on waterward end.					
Concrete "U" headwall on landward end. Originally included in USACE O+M manual (1963). As-built drawing No. 50-4-3622.					
FS Date: 10/3/2013

Concrete U-shaped headwall on WS slope.

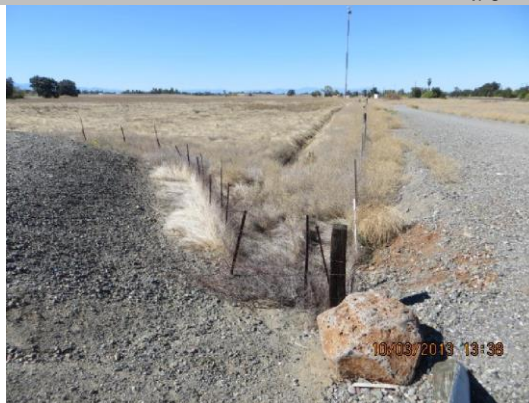
Photo 2 of 3 : UCIP\_SP\_2017\_21763\_36981.jpg

LM Start	2.21	Rating **	A/W	Issue No.	933 (cont)
LM End	2.21	Issue Type +	Ma	Location *	WS
Category	Supplemental			GPS Latitude/Longitude	
				Start	End
Item	DWR UCIP LMA Responsibility			40.051985 °	40.051985 °
				-122.150737 °	-122.150737 °
DWR ID					
Comment Code					
Inspector Comment					
FS_ID:21763					
DS_ID:20788					
EP_NO: N/A					
Repair Type: No Action Needed					
Crossing Status: Found					
UCIP Comments:					
FIELD_STRUCT_DESC: 24-inch CM pipe through levee, 5.9 feet below crown. Flap gate and concrete "U" headwall on waterward end.					
Concrete "U" headwall on landward end. Originally included in USACE O+M manual (1963). As-built drawing No. 50-4-3622.					
FS Date: 10/3/2013

Inlet off LS toe in channel.

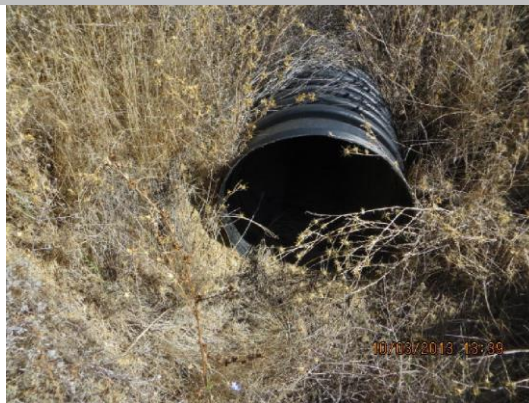
Photo 3 of 3 : UCIP\_SP\_2017\_21763\_36980.jpg

HDPE pipe inlet on LS toe.

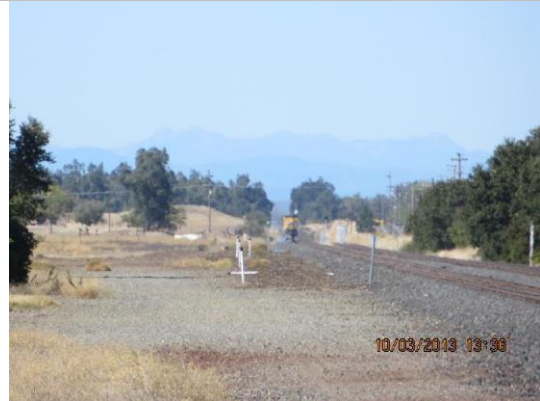
Photo 1 of 1 : UCIP\_SP\_2017\_23051\_39135.jpg

LM Start	2.23	Rating **	M	Issue No.	934
LM End	2.23	Issue Type +	En	Location *	WS
Category	Supplemental			GPS Latitude/Longitude	
				Start	End
Item	DWR UCIP Field Study			40.052063 °	40.052063 °
				-122.150450 °	-122.150450 °
DWR ID					
Comment Code					
Inspector Comment					
FS_ID:23051 DS_ID:24695 EP_NO: N/A Repair Type: Non-Urgent Crossing Status: Found UCIP Comments: No permit identified for this crossing. FIELD_STRUCT_DESC: Fiber optic line through the levee at an unknown depth below the crown. Signage on LS visible. FS Date: 10/3/2013

Fiber optic line markers off LS shoulder.

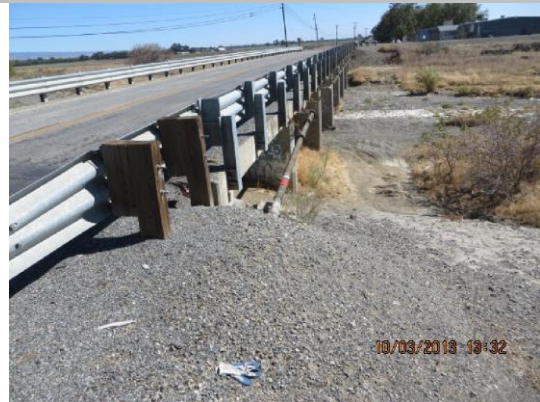
Photo 1 of 2 : UCIP\_SP\_2017\_23045\_39106.jpg

LM Start	2.28	Rating **	M	Issue No.	935
LM End	2.28	Issue Type +	En	Location *	WS
Category	Supplemental			GPS Latitude/Longitude	
				Start	End
Item	DWR UCIP Field Study			40.052379 °	40.052379 °
				-122.149534 °	-122.149534 °
DWR ID					
Comment Code					
Inspector Comment					
FS_ID:23045 DS_ID:24694 EP_NO: N/A Repair Type: Non-Urgent Crossing Status: Found UCIP Comments: No permit identified for this crossing. FIELD_STRUCT_DESC: 4-inch gasline through the levee 3.5-feet below the crown. Pipe visible on upstream side of bridge. FS Date: 10/3/2013

Gasline on upstream side of bridge.

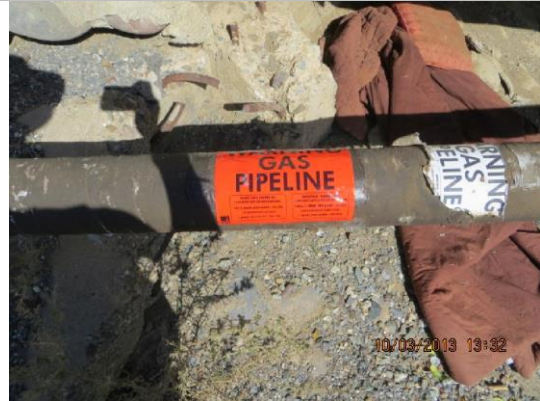
Photo 2 of 2 : UCIP\_SP\_2017\_23045\_39105.jpg

LM Start	2.28	Rating **	M	Issue No.	935 (cont)	
LM End	2.28	Issue Type +	En	Location *	WS	
Category	Supplemental			GPS Latitude/Longitude		
				Start	End	
Item	DWR UCIP Field Study			40.052379 °	40.052379 °	
				-122.149534 °	-122.149534 °	
DWR ID						
Comment Code						
Inspector Comment						
FS_ID:23045						
DS_ID:24694						
EP_NO: N/A						
Repair Type: Non-Urgent						
Crossing Status: Found						
UCIP Comments: No permit identified for this crossing.						
FIELD_STRUCT_DESC: 4-inch gasline through the levee 3.5-feet below the crown. Pipe visible on upstream side of bridge.						
FS Date: 10/3/2013

Gasline on upstream side of bridge.

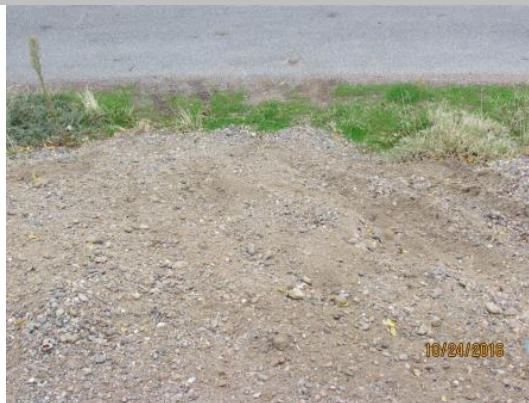
Photo 1 of 1 : SP\_2017\_NA0019\_81\_30\_20170315\_00019.jpg

LM Start	2.35	Rating **	M	Issue No.	30
LM End	2.35	Issue Type +	Ma	Location *	LS
Category	Earthen Levee			GPS Latitude/Longitude	
				Start	End
Item	Slope Stability			40.052450 °	40.052450 °
				-122.148352 °	-122.148352 °
DWR ID	DWR_NA0019_04_f_2016_30				
Comment Code					
S3 : Repair the levee slope damaged by vehicle traffic and prevent access where possible.					
Inspector Comment

View of the slope instability caused by vehicles along the landside slope.

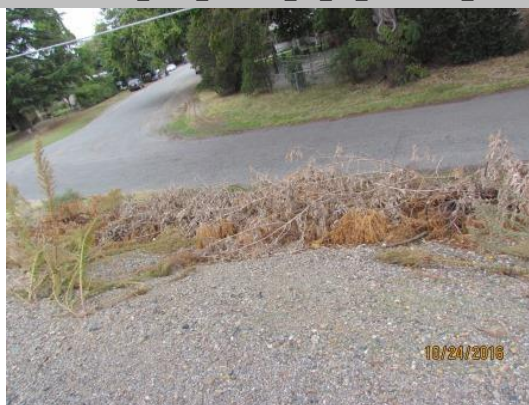
Photo 1 of 1 : SP\_2017\_NA0019\_81\_31\_20170315\_00020.jpg

LM Start	2.37	Rating **	M	Issue No.	31
LM End	2.37	Issue Type +	En	Location *	LS
Category	Earthen Levee			GPS Latitude/Longitude	
				Start	End
Item	Encroachments			40.052451 °	40.052451 °
				-122.147962 °	-122.147962 °
DWR ID	DWR_NA0019_04_f_2016_31				
Comment Code					
PR : Prunings					
Inspector Comment					
Remove prunings from the landside toe.

View of the prunings along the landside toe.

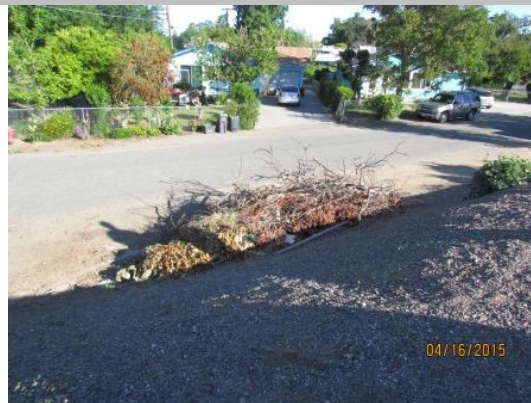
Photo 1 of 2 : SP\_2017\_NA0019\_81\_15\_20170315\_00009.jpg

LM Start	2.63	Rating **	M	Issue No.	15
LM End	2.63	Issue Type +	En	Location *	LS
Category	Earthen Levee			GPS Latitude/Longitude	
				Start	End
Item	Encroachments			40.054337 °	40.054337 °
				-122.144235 °	-122.144235 °
DWR ID	DWR_NA0019_04_s_2015_15				
Comment Code					
PR : Prunings					
Inspector Comment					
Remove the prunings from the landside toe.

View of the prunings along the landside toe.

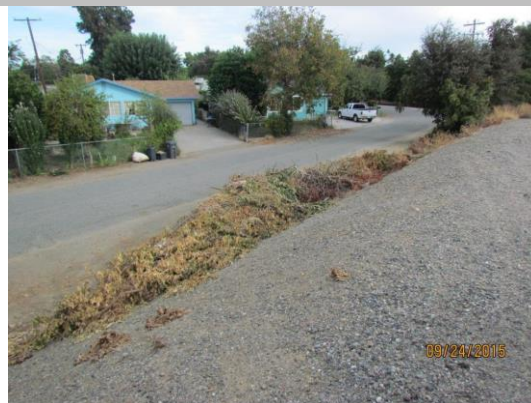
Photo 2 of 2 : SP\_2017\_NA0019\_81\_15\_20170315\_00010.jpg

View of the prunings along the landside toe.

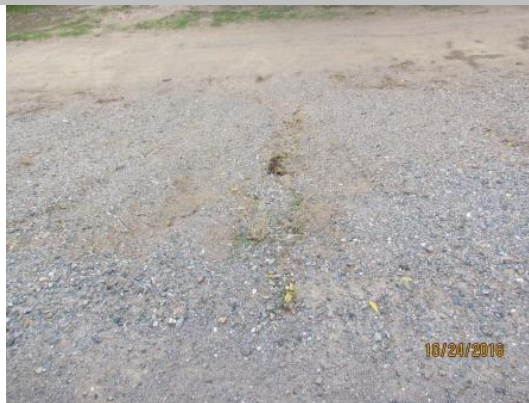
Photo 1 of 1 : SP\_2017\_NA0019\_81\_916\_20170315\_00025.jpg

LM Start	2.83	Rating **	M	Issue No.	916
LM End	2.86	Issue Type +	Ma	Location *	LS
Category	Earthen Levee			GPS Latitude/Longitude	
				Start	End
Item	Slope Stability			40.055596 °	40.055985 °
				-122.141322 °	-122.141385 °
DWR ID	DWR_NA0019_04_s_2012_916				
Comment Code					
S3 : Repair the levee slope damaged by vehicle traffic and prevent access where possible.					
Inspector Comment

View of the slope instability caused by vehicles along the landside slope.

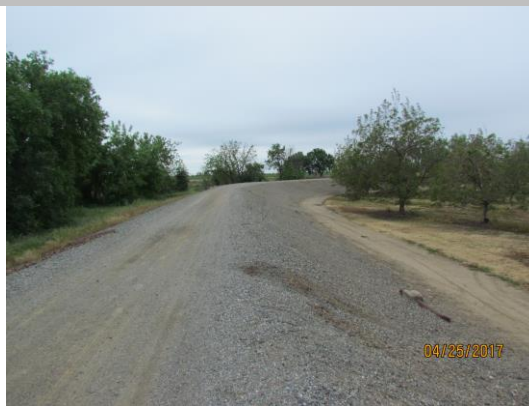
Photo 1 of 1 : SP\_2017\_NA0019\_81\_52\_20170505\_00080.jpg

LM Start	2.86	Rating **	A	Issue No.	52
LM End	2.86	Issue Type +	Ma	Location *	LS
Category	Earthen Levee			GPS Latitude/Longitude	
				Start	End
Item	Vegetation			40.056027 °	40.056027 °
				-122.141392 °	-122.141392 °
DWR ID	DWR_NA0019_04_s_2017_52				
Comment Code					
V1 : Control annual grass and weeds on the levee slopes and easements.					
Inspector Comment					
The vegetation was removed from both slopes.

View of no vegetation on both slopes.

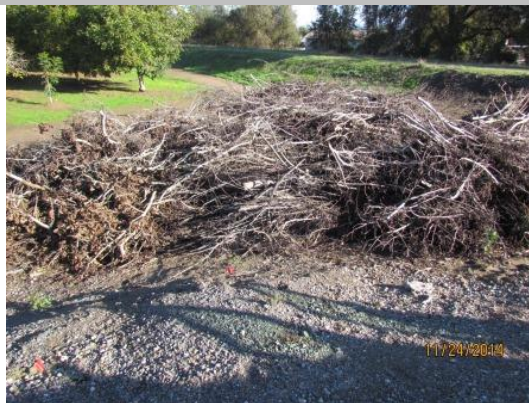
Photo 1 of 1 : SP\_2017\_NA0019\_81\_17\_20170315\_00012.jpg

LM Start	3.01	Rating **	M	Issue No.	17
LM End	3.01	Issue Type +	En	Location *	LS
Category	Earthen Levee			GPS Latitude/Longitude	
				Start	End
Item	Encroachments			40.056448 °	40.056448 °
				-122.139302 °	-122.139302 °
DWR ID	DWR_NA0019_04_f_2014_17				
Comment Code					
PR : Prunings					
Inspector Comment					
Remove prunings from the landside toe.

View of the prunings along the landside slope.

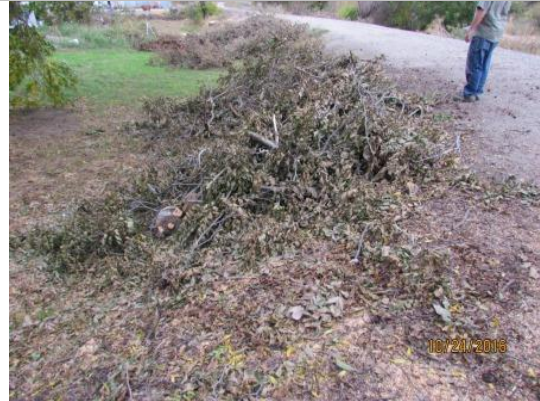
Photo 1 of 1 : SP\_2017\_NA0019\_81\_35\_20170315\_00022.jpg

LM Start	3.05	Rating **	M	Issue No.	35
LM End	3.10	Issue Type +	En	Location *	LS
Category	Earthen Levee			GPS Latitude/Longitude	
				Start	End
Item	Encroachments			40.056405 °	40.056935 °
				-122.138438 °	-122.138029 °
DWR ID	DWR_NA0019_04_f _ 2016_35				
Comment Code					
PR : Prunings					
Inspector Comment					
Remove prunings from the landside toe.

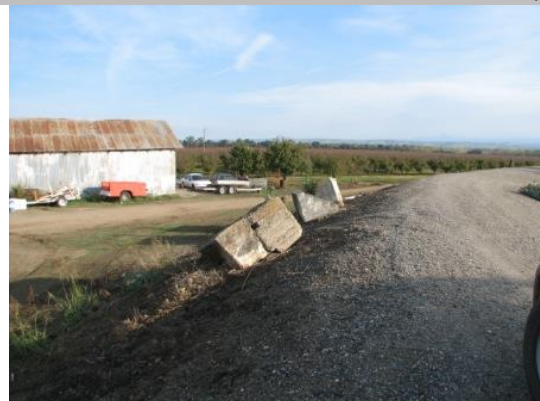
Photo 1 of 1 : SP\_2017\_NA0019\_81\_1\_20170315\_00001.jpg

LM Start	3.11	Rating **	M	Issue No.	1
LM End	3.13	Issue Type +	Ma	Location *	LS
Category	Earthen Levee			GPS Latitude/Longitude	
				Start	End
Item	Encroachments			40.057083 °	40.057291 °
				-122.137935 °	-122.137743 °
DWR ID	DWR_NA0019_04_s_2012_1				
Comment Code					
ST : Stairway					
Inspector Comment					
Remove concrete blocks, concrete pipes, and concrete stairs from the landside slope.

View of the concrete stairways on the slope.

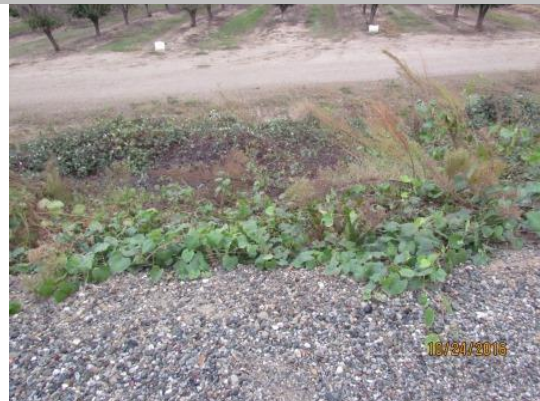
Photo 1 of 1 : SP\_2017\_NA0019\_81\_39\_20170315\_00023.jpg

LM Start	3.40	Rating **	M	Issue No.	39
LM End	3.44	Issue Type +	Ma	Location *	LS
Category	Earthen Levee			GPS Latitude/Longitude	
				Start	End
Item	Vegetation			40.056546 °	40.055906 °
				-122.133530 °	-122.133294 °
DWR ID	DWR_NA0019_04_f_2016_39				
Comment Code					
V2 : Remove the wild growth other than native grasses from the levee slopes.					
Inspector Comment

View of the blackberries along the landside slope blocking visibility and access.

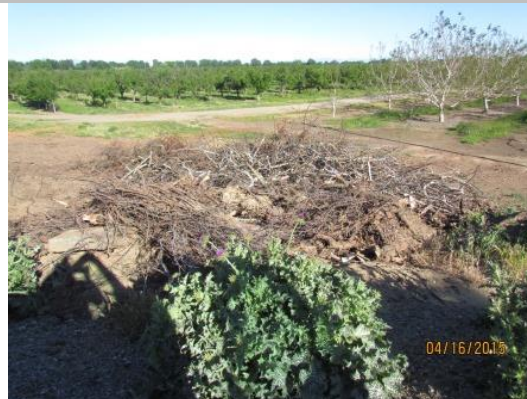
View of the prunings along landside toe.

LM Start	3.66	Rating **	M	Issue No.	21
LM End	3.66	Issue Type +	En	Location *	LS
Category	Earthen Levee			GPS Latitude/Longitude	
				Start	End
Item	Encroachments			40.055735 °	40.055735 °
				-122.129445 °	-122.129445 °
DWR ID	DWR_NA0019_04_s_2015_21				
Comment Code					
PR : Prunings					
Inspector Comment					
Remove the prunings from the landside toe.

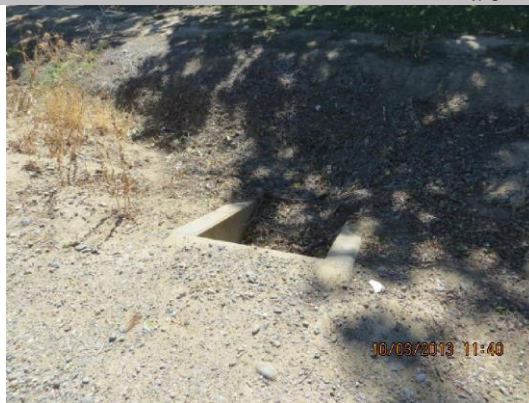
Photo 1 of 3 : UCIP\_SP\_2017\_21744\_36945.jpg

LM Start	0.11	Rating **	A/W	Issue No.	20
LM End	0.11	Issue Type +	Ma	Location *	LS
Category	Supplemental			GPS Latitude/Longitude	
				Start	End
Item	DWR UCIP LMA Responsibility			40.051702 °	40.051702 °
				-122.189922 °	-122.189922 °
DWR ID					
Comment Code					
Inspector Comment					
FS_ID:21744					
DS_ID:20799					
EP_NO: N/A					
Repair Type: No Action Needed					
Crossing Status: Found					
UCIP Comments:					
FIELD_STRUCT_DESC: 24-inch CM drainpipe through the levee, 5.4 feet below the crown. Flap gate on waterward end. Concrete "U" headwalls on the waterward and landward ends. Originally included in USACE O+M Manual (1963). As-built drawing 50-4-3622					
FS Date: 10/3/2013

Concrete headwall on LS toe.

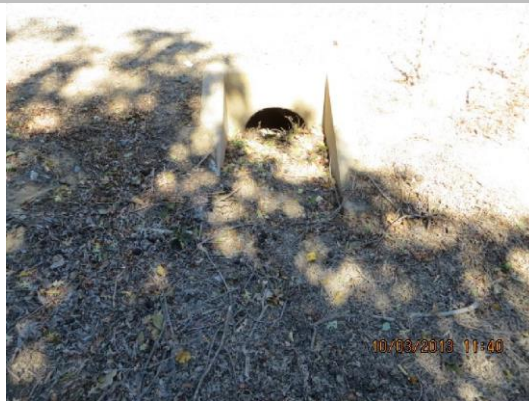
Photo 2 of 3 : UCIP\_SP\_2017\_21744\_36944.jpg

Concrete headwall on LS toe.

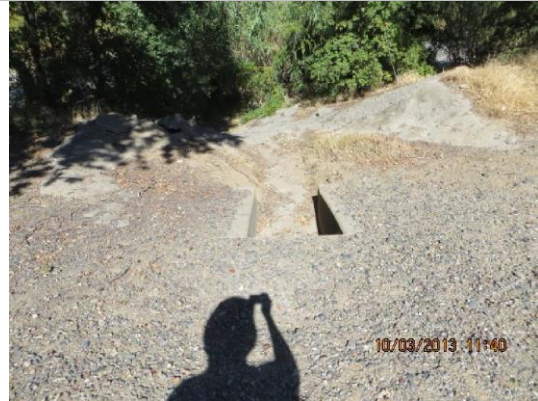
Photo 3 of 3 : UCIP\_SP\_2017\_21744\_36943.jpg

LM Start	0.11	Rating **	A/W	Issue No.	20 (cont)
LM End	0.11	Issue Type +	Ma	Location *	LS
Category	Supplemental			GPS Latitude/Longitude	
				Start	End
Item	DWR UCIP LMA Responsibility			40.051702 °	40.051702 °
				-122.189922 °	-122.189922 °
DWR ID					
Comment Code					
Inspector Comment					
FS_ID:21744					
DS_ID:20799					
EP_NO: N/A					
Repair Type: No Action Needed					
Crossing Status: Found					
UCIP Comments:					
FIELD_STRUCT_DESC: 24-inch CM drainpipe through the levee, 5.4 feet below the crown. Flap gate on waterward end. Concrete "U" headwalls on the waterward and landward ends. Originally included in USACE O+M Manual (1963). As-built drawing 50-4-3622					
FS Date: 10/3/2013

Concrete U-shaped headwall on WS slope.

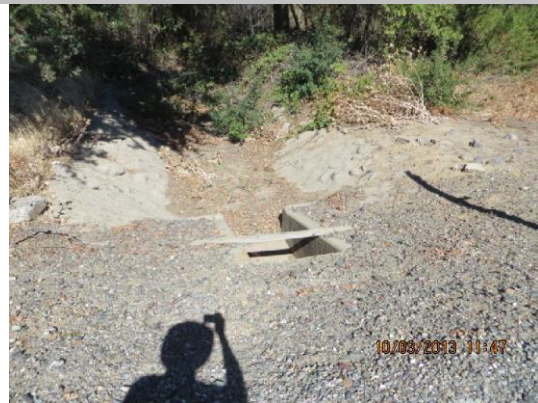
Photo 1 of 3 : UCIP\_SP\_2017\_41124\_36953.jpg

LM Start	0.50	Rating **	M	Issue No.	21
LM End	0.50	Issue Type +	Ma	Location *	LS
Category	Supplemental			GPS Latitude/Longitude	
				Start	End
Item	DWR UCIP LMA Responsibility			40.050585 °	40.050585 °
				-122.182972 °	-122.182972 °
DWR ID					
Comment Code					
Inspector Comment					
FS_ID:41124					
DS_ID:20801					
EP_NO: N/A					
Repair Type: Non-Urgent					
Crossing Status: Found					
UCIP Comments: Debris inside pipe at WS toe needs to be removed as it may prevent proper operation of the flapgate.					
FIELD_STRUCT_DESC: 24-inch CM pipe through the levee, 5.2 feet below the crown. Flap gate on waterward end. Concrete "U" headwalls on the waterward and landward ends. Originally included in USACE O+M Manual (1963). As-built drawing 50-4-3622					
FS Date: 10/3/2013

Concrete headwall on WS toe.

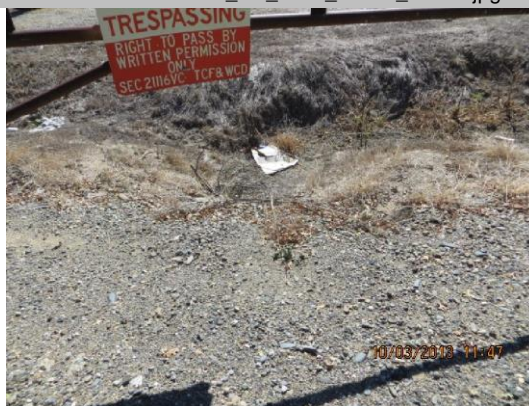
Photo 2 of 3 : UCIP\_SP\_2017\_41124\_36952.jpg

Inlet at LS toe.

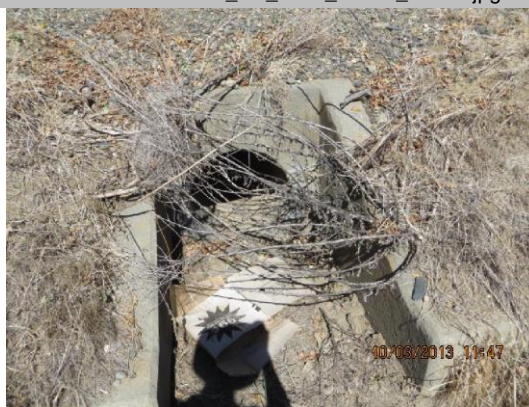
Photo 3 of 3 : UCIP\_SP\_2017\_41124\_36951.jpg

Concrete headwall at LS toe.
